TS-PIC-89714 March 1989

AERIAL PHOTOGRAPHIC ANALYSIS OF ROCKWELL HANFORD OPERATIONS AREA 100H Richland, Washington

AERIAL PHOTOGRAPHIC ANALYSIS OF ROCKWELL HANFORD OPERATIONS AREA 100H

Richland, Washington

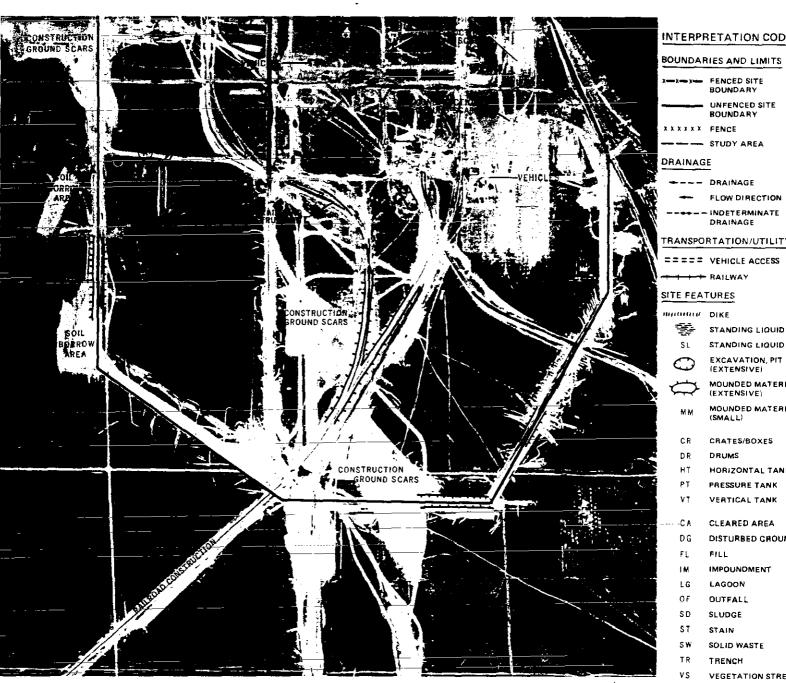
Rockwell Hanford Operations Area 100H, South May 25, 1948. Approximate Figure 3. scale 1:11,000.

The 1948 photographs (Figure 3 and 4) show the extreme north and southern portions of the Department of Energy, Rockwell Hanford Operations Area 100H study site; complete photo coverage of the study area for this year was not available. The entire site appears under construction. The widespread ground scars are a result of earthmoving activity to clear and level areas prior to erection of buildings and construction of roadway and railroad beds.

One large pit (Figure 3, Annotation A) in the west portion of the site appears to be associated with waste disposal activity because of its proximity to two apparent trenches. Another pit (Figure 4, Annotation B) at the northern portion of the site also appears to related to waste disposal due to its isolation. A third pit (Annotation C) is adjacent to a center of construction and its purpose is unknown.

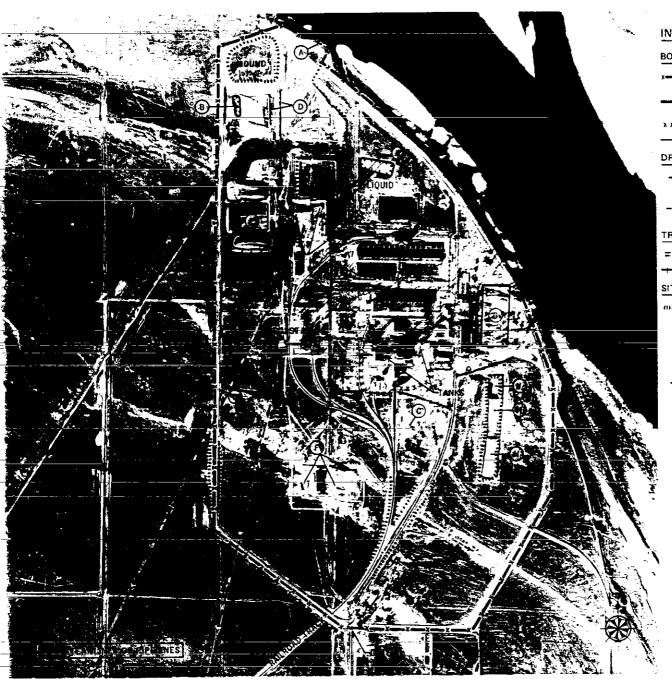
Rockwell Hanford Operations Area 100H, November 2, 1964. Approximate scale 1:8,900.

The 1964 photograph (Figure 5) shows the fence secured Rockwell Hanford Operations Area 100H is completed. Several vehicles are observed throughout the compound and in parking lots. Area 100H is served by road, railroad, electric power transmission lines, and a probable buried pipeline. The facility consists of several processing buildings connected by probable steam, above ground, pipelines; a steam/power plant; an electric substation; large cooling ponds/lagoons; support/administration building; and several disposal pits and/or trenches. There is a probable cooling water intake pumping station at the extreme north end of the site, on the bank of the Columbia River (Annotation A).

The pits described of the 1948 photo (Figure 3, Annotation A and C) are absent except for ground scarring (Annotations C). The pit at the north end of the site now appears as a trench, suggesting it has been partially filled in since 1948 (Figure 4, Annotation B).

There are several areas at this facility where waste disposal pits or trenches $\bar{a}\bar{r}\bar{e}$ observed. Adjacent to the previously mentioned pit/trench (Annotation B) there are two long trenches (Annotation D), a very wide pit surrounded by three spoil mounds is along the site's west perimeter (Annotation E), and a group of three small pits are at the southern portion of the site (Annotation F). No vehicles are visible discharging waste at any of these locations.

The facility also has several lagoons where liquids are handled, the largest stucture appears to be a cooling pond (Annotation G). There are three lagoons (Annotations H and J) and a pit (Annotation I) that appear to receive waste liquids.

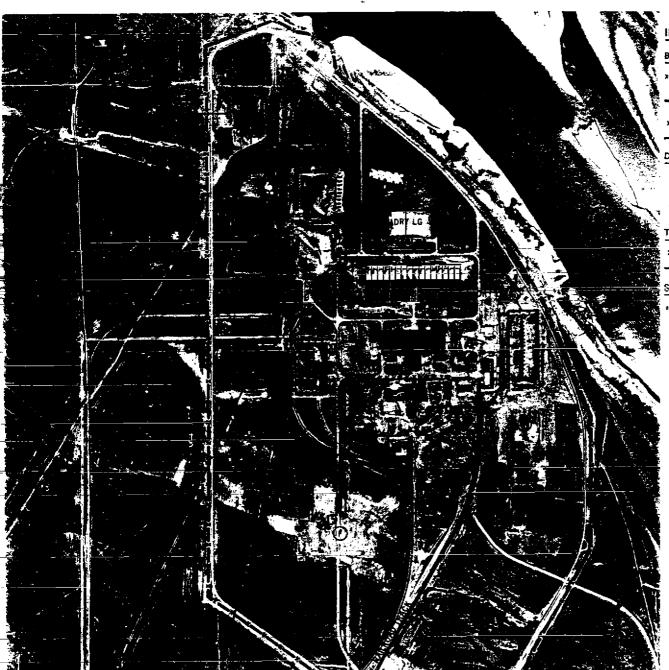
Figure 6. Rockwell Hanford Operations Area 100H, August 1973. Approximate scale 1:8,500.

The 1973 photograph (Figure 6) suggests Area 100H is no longer operational and being dismantled. The steam/power plant has been dismantled (Annotation A), the support/administration buildings are removed (Annotation B), and the steam pipelines are disconnected.

The majority of disposal pits, trenches, and lagoons noted in 1964 have been covered up. The pit/trench at the north end of the site in 1964 (Figure 5, Annotation B) is absent (Annotation C). The trenches seen in the same northern area in 1964 (Figure 5, Annotation D) are also burried (Annotation D). The group of three small pits in 1964 (Figure 5, Annotation F) are covered over (Annotation F). The cooling pond is now empty (Annotation G) and the other lagoons and pit south of this cooling pond observed in 1964 (Figure 5, Annotations H and I) are absent (Annotations H and I). The other lagoons at the site are empty to suggest the facility is being shut down. Only the largest pit appears unchanged (Annotation E).

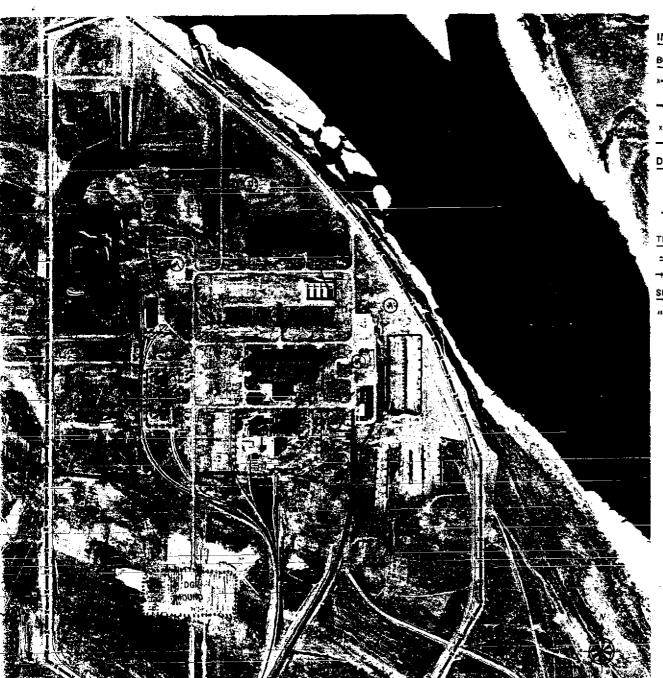
Rockwell Hanford Operations Area 100H, August 1976. Approximate Figure 7. scale 1:7,500.

The 1976 photograph (Figure 7) reveals the dismantling of buildings and closure of Area 199H has continued since 1973. Additional buildings are removed and several remains/ruins of building foundations are visible (Annotations A). The three large lagoons in the northern portion of the facility are absent, only ground scars are discernable (Annotations B, C, and D). The large pit at the west perimeter of the sit has also been filled in, a depression remains at this location (Annotation E).
